Research & Development Highlights

Technical Series
90-240

Wet-Sprayed Cellulose Insulation in Wood-Frame Construction

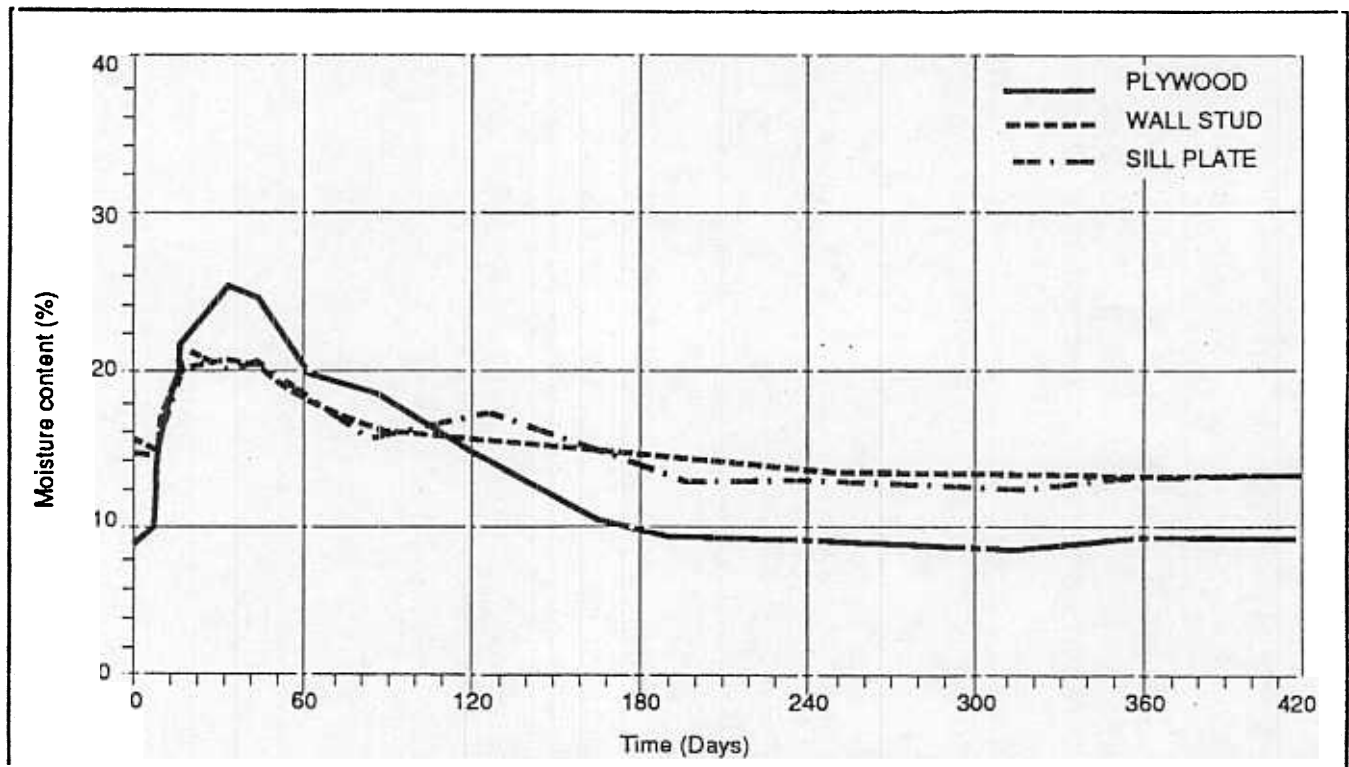
Average wall moisture contents

Sections of the frame adjacent to the dry insulation showed normal absorption and drying rates. After the wet-sprayed cellulose was installed, the plywood's sheathing moisture level increased to 26% after 30 days, decreased to near original levels (15%) after 160 days, and dried 1% more by the end of the test (420 days).

The framing timbers' moisture level increased to 22% in the first 10 days, dried to slightly over original levels (9%) after 80 days, and then dried 3% more by the end of the test (420 days). From these observations, the study concluded:
